Engine Performance Project

Vehicle: 2016 C-Max Hybrid/Energy

Concern: **Throttle response issue**

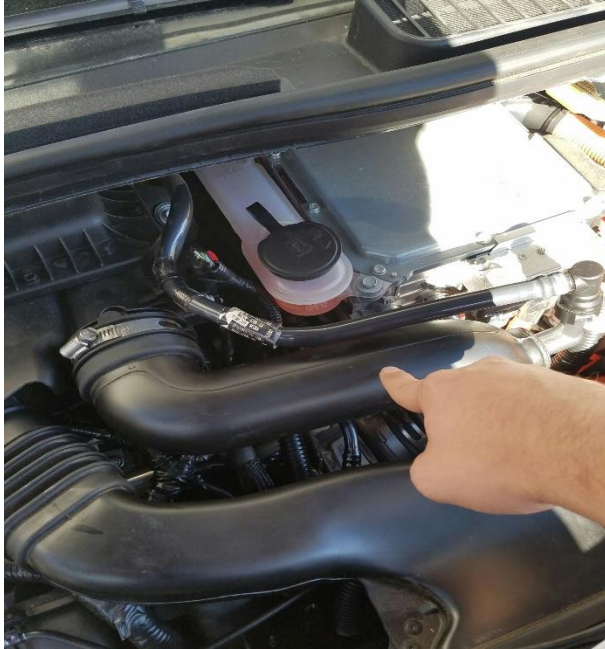
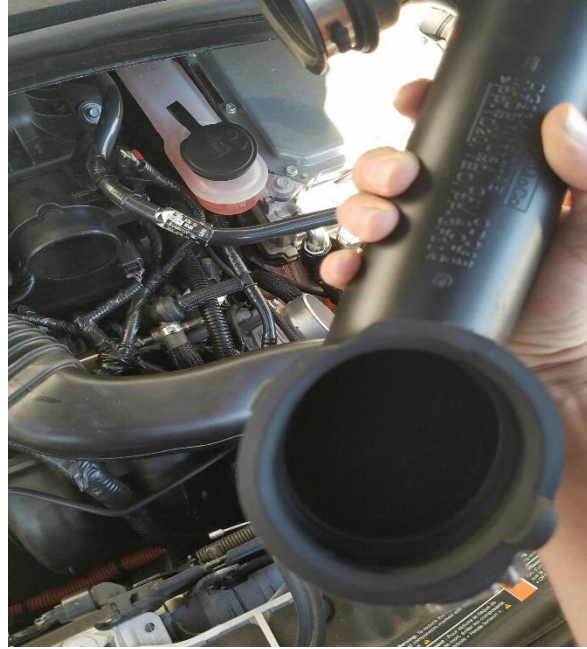
DV5 asked to check VREF Voltage to the TP Sensor. Is the voltage between 4.5v – 5.5v ?

ETCREF – PIN 5 [+]	ETCRTN – PIN 4 [-]
--------------------	--------------------

Yes the voltage was within specification at 5v. So we moved on to **DV6**.

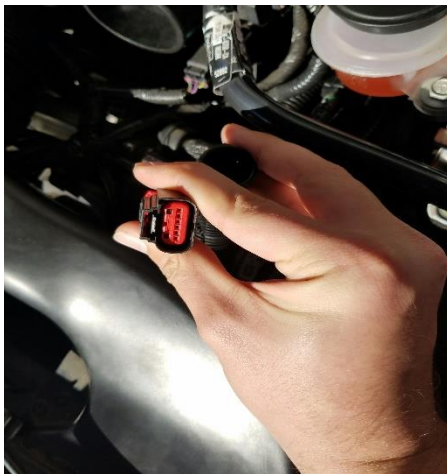
[In the Image how the connector is facing Pin 1 is the very top, and Pin 6 is the very bottom]

DV6 asked us to check the resistance of the TP Sensor, and if it was between 9k OHMS – 11k OHMS. It was not within at specification, we had high resistance at the connector. From there we racked the vehicle so we could check the wiring between the ETB [Electronic Throttle Body] and PCM [Powertrain Control Module]. We stopped following the pinpoint and went straight to the wiring diagrams for further information.

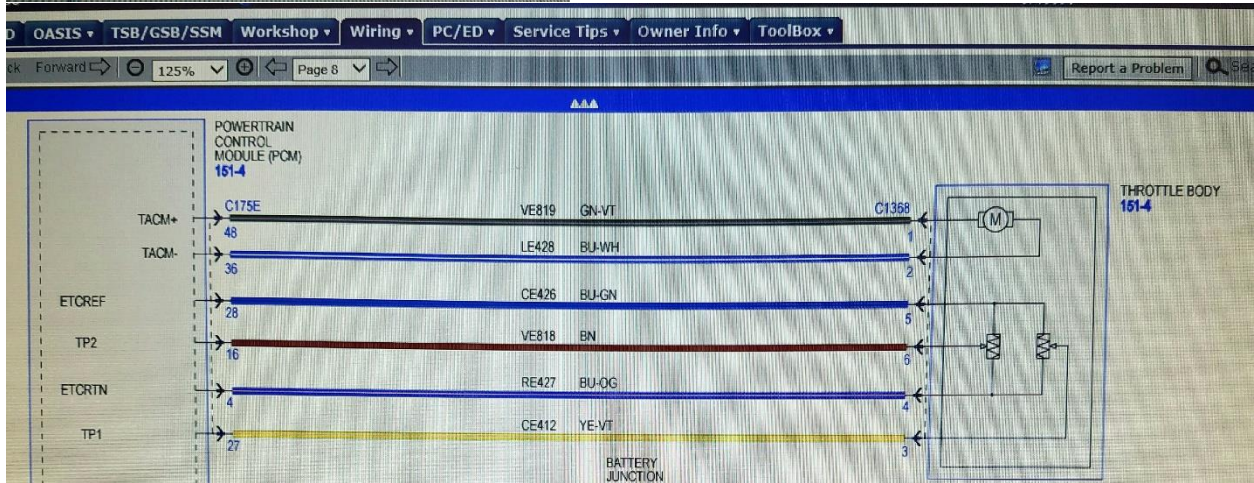
To find the diagram that we needed we went to [23-1 Electronic Engine Controls Pg.8]

ETCREF	PIN 28 to PIN 5	.6 OHMS	CE426 BU-GN
TP2	PIN 16 to PIN 6	.6 OHMS	VE818 BN
ETCRTN	PIN 4 to PIN 4	OPEN	RE427 BU-OG
TP1	PIN 27 to PIN 3	.6 OHMS	CE412 YE-VT

While conducting basic electrical testing [resistance checks] between the PCM and Throttle Body we found that the high resistance we found in the ETB connector was actually the ETCRTN wire being open. We repaired that circuit and retested finding that everything was functioning normally.
