Engine Performance Project

Vehicle: 2016 C-Max Hybrid/Energy

Concern: **Throttle response issue**

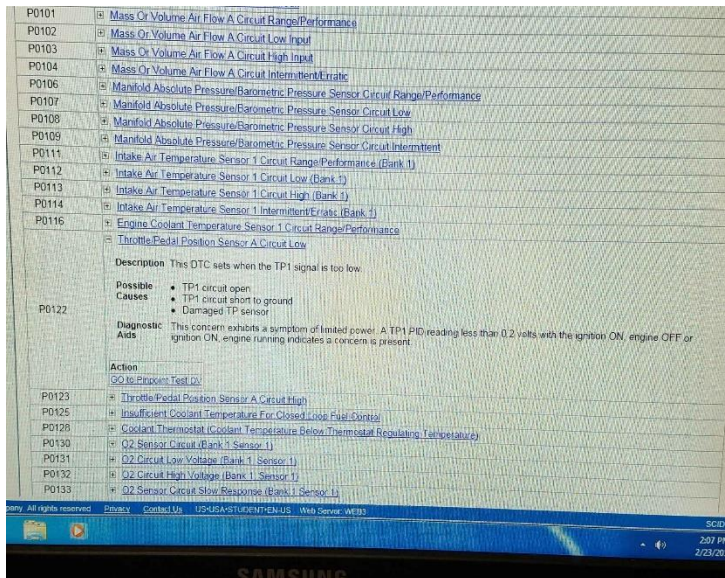
As we continued to do a self-test on the C-Max for all Commanded DTCs, many shown up but we decided to go off the most relevant to the concern: [P0122 Throttle/Pedal Position Sensor A Circuit Low] and continued to follow the pinpoint tests. To find the DTC code on PTS we had to go under PC/ED and choose [Powertrain DTC Charts and Descriptions] to get to the correct pinpoint test.

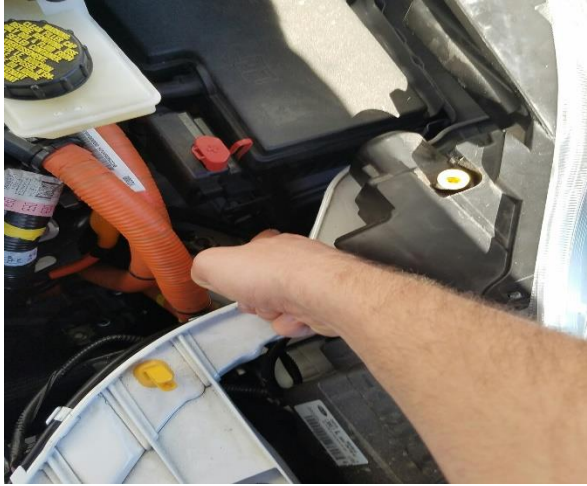
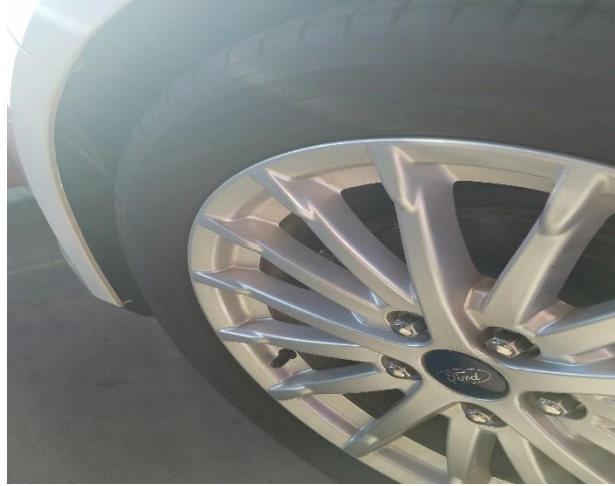
DV6 asked us to check the resistance of the TP Sensor, and if it was between 9k OHMS – 11k OHMS. It was not within at specification, we had high resistance at the connector. From there we racked the vehicle so we could check the wiring between the ETB [Electronic Throttle Body] and PCM [Powertrain Control Module]. We stopped following the pinpoint and went straight to the wiring diagrams for further information.

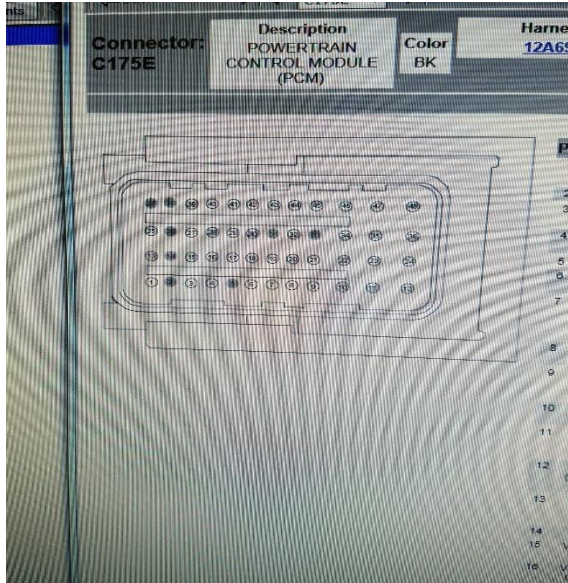
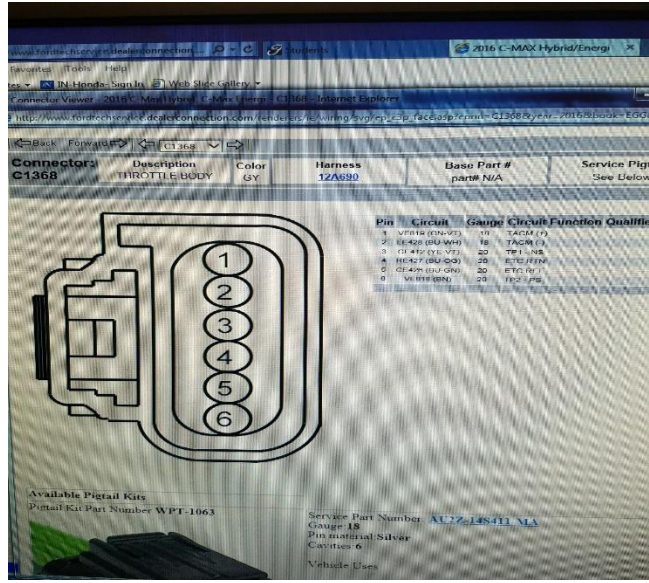
To find the diagram that we needed we went to [23-1 Electronic Engine Controls Pg.8]

The PCM is located under the BJB [Battery Junction Box] in its own enclosure. The easiest way to access the PCM is to take off the left front tire and driver-side front wheel-well. From there you can take off the 5 bolts holding the cover in place to access the PCM connectors.

ETCREF	PIN 28 to PIN 5	.6 OHMS	CE426 BU-GN
TP2	PIN 16 to PIN 6	.6 OHMS	VE818 BN
ETCRTN	PIN 4 to PIN 4	OPEN	RE427 BU-OG
TP1	PIN 27 to PIN 3	.6 OHMS	CE412 YE-VT

While conducting basic electrical testing [resistance checks] between the PCM and Throttle Body we found that the high resistance we found in the ETB connector was actually the ETCRTN wire being open. We repaired that circuit and retested finding that everything was functioning normally.
